CEMINTEL®

# Fire Performance Guide for Fibre Cement Cladding

White Paper  
JUNE 2019

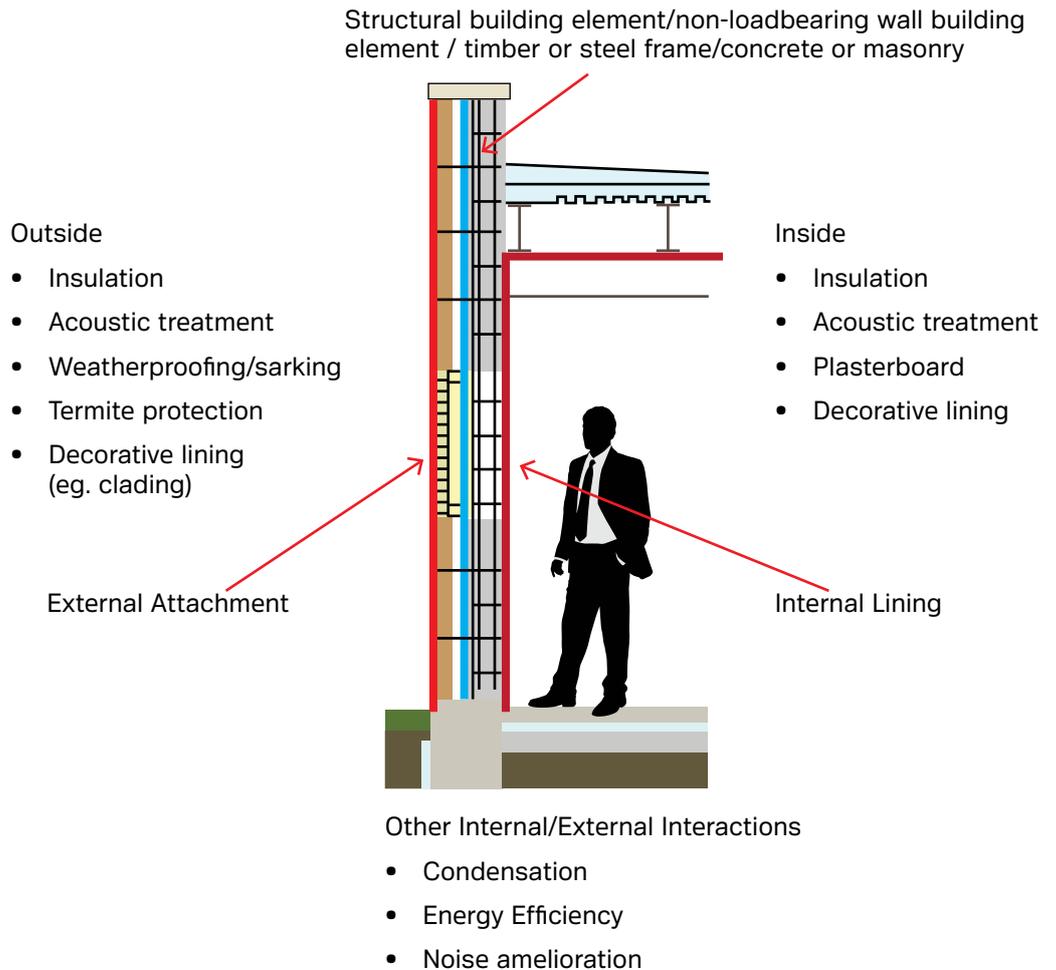
### Components of a Basic Wall

## WHAT IS A WALL?

Some challenges relating to the wall?

- Acoustics, weatherproofing and fire resistance – these are supposed to be identical to the tested prototype
- Energy efficiency of the total wall system
- BCA DtS wall to be non-combustible
- Minimum performance levels must be achieved
- No DtS for weatherproofing
- Full performance options

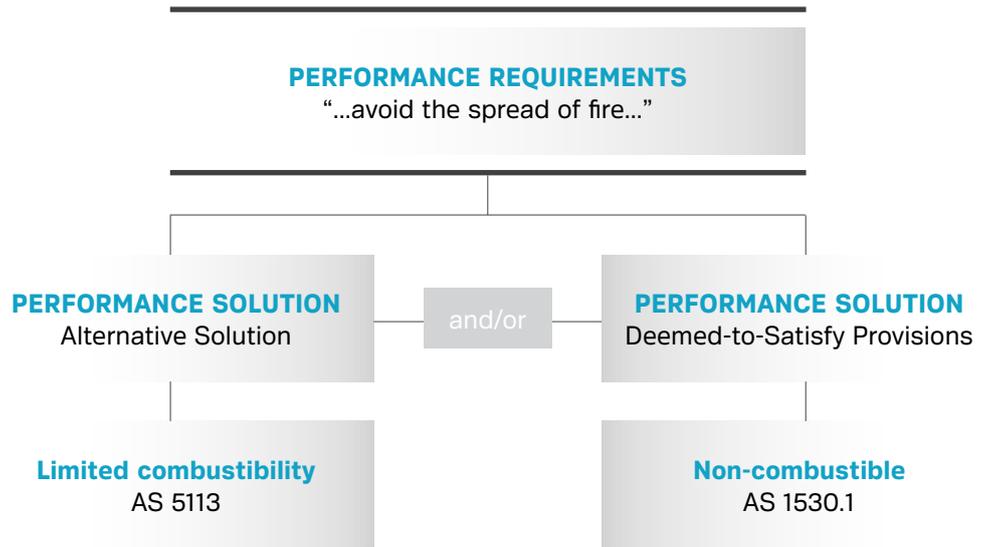
There are 2 pathways for compliance under the BCA:

NOTE: DtS provisions allow building materials to be used in certain ways without the need for further verification. For example, fibre cement or plasterboard may be used where a non-combustible material is required without any further need to demonstrate compliance. All Cemintel panels are fibre cement and there is no need to illustrate suitability. Instead reference can be made to BCA Clause C1.9. To assist with specifications, Fire Certificates are available for downloading from the website at [cemintel.com.au](http://cemintel.com.au)

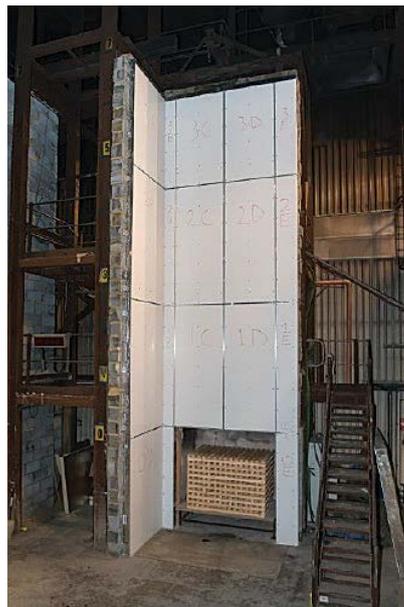
AS 5113

This is the test rig for AS 5113, based on the rig used for BRE testing in Europe. The test time is 30 minutes.

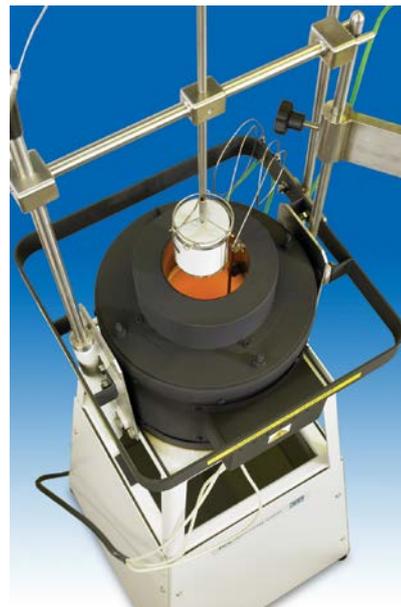
AS1530

This is a furnace for AS1530.1 testing. A 45mm (d) x 50mm (t) piece of material is dropped into the furnace at a temperature of 750°C for 30 minutes.

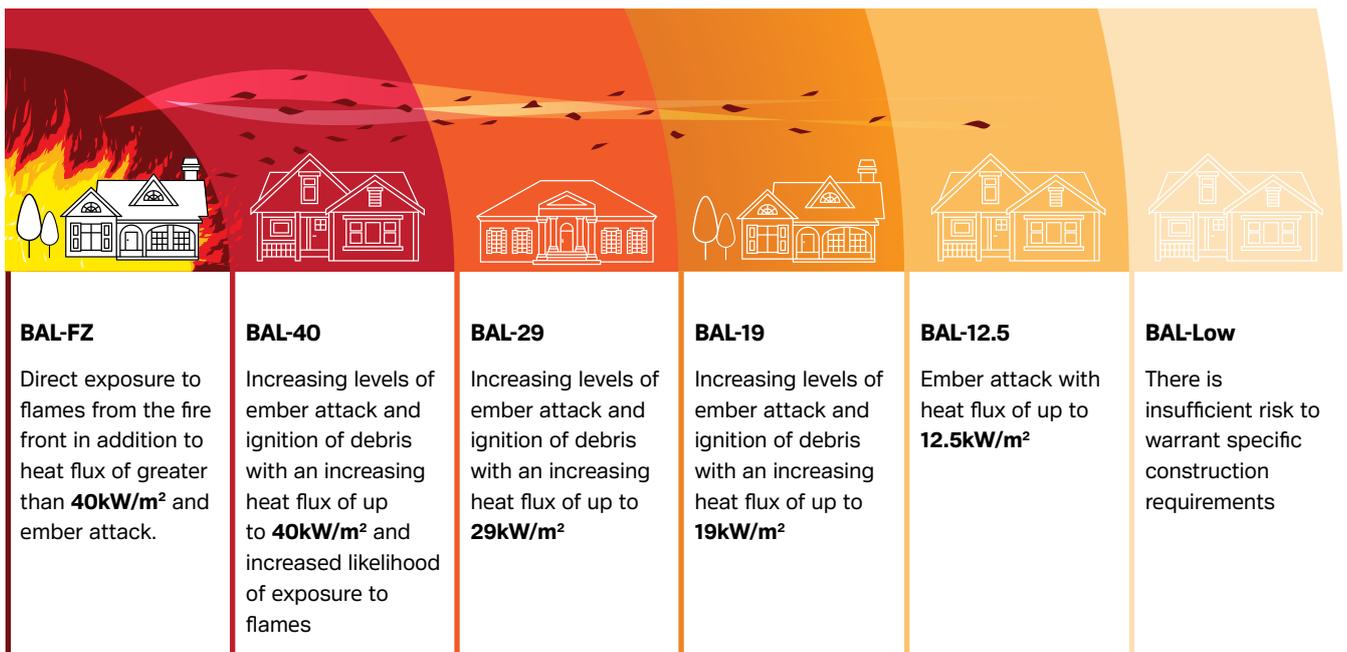
Once assessed, your site/property/asset will be defined to one of six BAL ratings:

The image above shows the various BAL ratings and the radiant heat flux for each rating. The greater the distance from the fire the lower the heat flux and therefore the construction standard is lower.

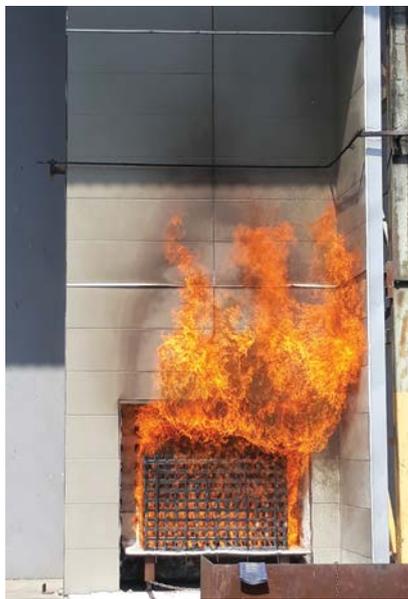
9min

The images below illustrate the AS 5113 test for Territory. Territory is a unique product in that it satisfies the DtS requirements of the BCA, and additionally has passed the AS 5113 test with an EW rating.

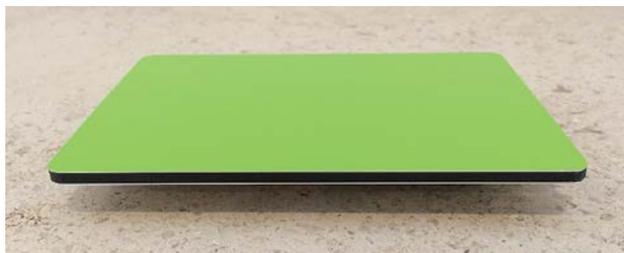
Figure 2: ACP

ACP is made of 3 layers – a core material which is bonded to a thin skin-layer on each side. They are also referred to as sandwich panels.

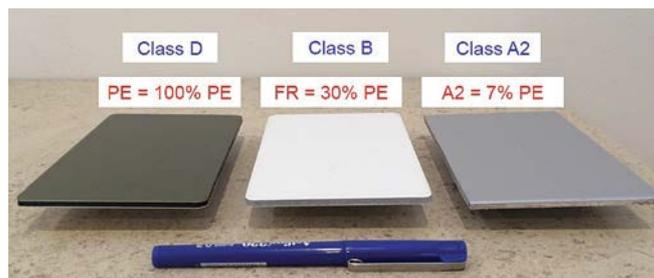
Figure 3 shows the 3 Classes that are used in construction.

Figure 3: Classification of ACP products (Source: Tony Enright, December 2017)

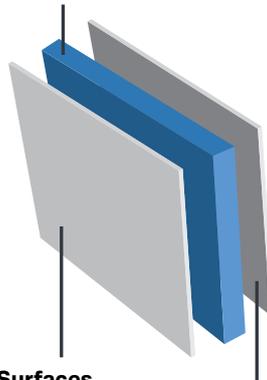
**Insulating core** 2-5mm thick, 100% polyethylene

**Surfaces**  
0.5mm thick 100% aluminium skin

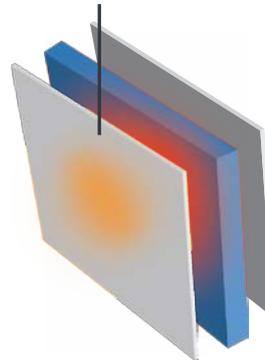
Heat from a fire will conduct quickly to the core through thin aluminium

Core loses ability to bind, causing outer skins to deform and delaminate.

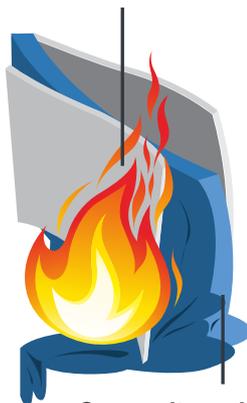
**Core melts and can ignite**

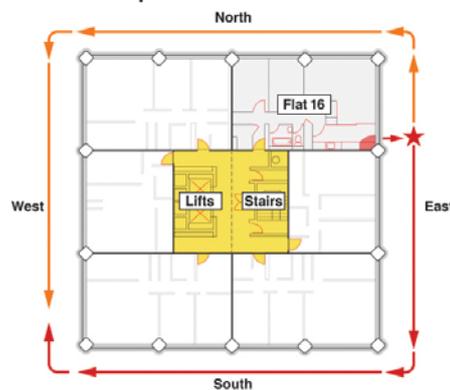
#### How the fire spread

- ★ **ROUTE ONE** ← 01:09 - 01:14 Fire spreads from kitchen window to external facade and upwards to 23rd floor by 01:26. Reaches north side by 01:42
- ★ **ROUTE TWO** ← 01:52 Fire on east side begins travelling towards south side in other direction

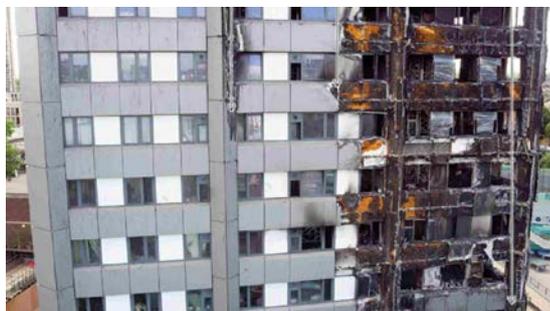
Images after the fire show evidence of melted cladding on the tower’s columns

The most significant part of the renovation of Grenfell Tower was the addition of external cladding. This consisted of aluminium sheets bonded to a central plastic (polyethylene) core.

In his report to the public inquiry, Professor Luke Bisby said evidence “strongly supports” the theory that the polyethylene material in the cladding was the primary cause of the fire’s spread.

“The ACM (aluminium composite material) product on Grenfell Tower incorporates a highly combustible polyethylene polymer filler which melts, drips, and flows at elevated temperature. The polyethylene filler material is expected to release large amounts of energy during combustion”.

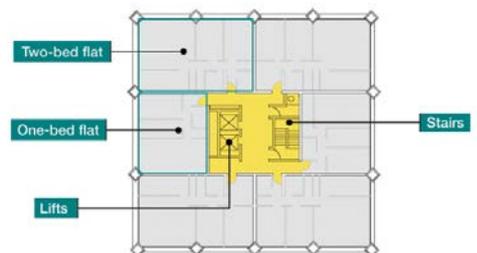
### Typical residential floor in Grenfell Tower

There were 129 flats across 21 residential floors and three levels of mixed use.
